CASE STUDY NUMBER:	Case Study 15
DESCRIPTION:	14" ELBOW DIAMOND WRAP WITH STRONGBACK
CLIENT:	TENGIZCHEVROIL

SERVICE:	
Line size	14"
Design Pressure	4
Operating Pressure	1,1
Design Temperature	160
Operating Temperature	120
Material	SA-516 Gr 70N
Line Class	150

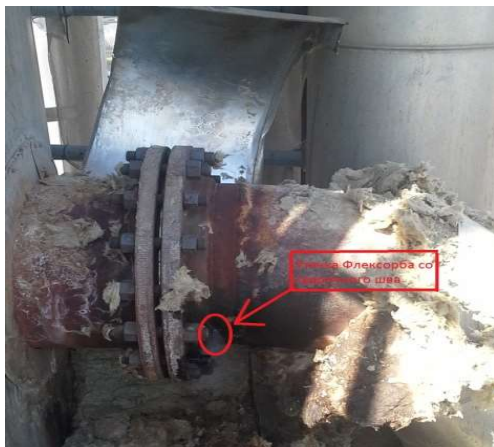
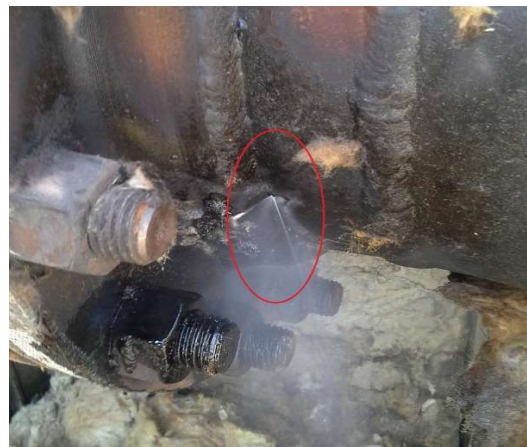
Operations reported a leak of flexorb. The external inspection found the leak through a hole with a diameter less than 1mm on the piping straight section 40mm wide within HAZ of the flange connection attachment weld. The leak was repaired temporarily for short-term period. Ultrasonic thickness test was performed within the leaking area and on the adjacent sections of the piping. Thickness of the damaged straight section was $T = 3.6 \div 4.6\text{mm}$, thickness of the adjacent sections is $T = 8.9 \div 9.6\text{mm}$.

Original thickness of the damaged pipe section does not meet requirements of class 150K01 ($T = 7.92\text{mm}$). It is not possible to calculate the corrosion rate because the thickness initial value is uncertain. Due to this piping being below specification further deterioration of piping could cause worsening leaks and ultimately failure

Operations of the piping with these non-conformities is not allowed

By Using a patch and strap the leak through the hole could temporarily be stopped to enable Beruseal to do a carbon fibre Composite repair to rebuild wall thickness and stop the leak (Diamond wrap can not be applied to leaking components unless leaks can be stopped)

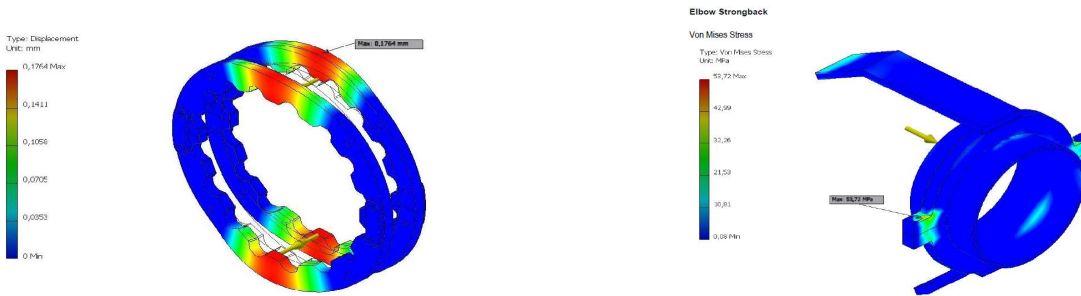
An FEA analysis was performed to calculate stresses in the strongback components in the event of failure on the design pressure.

Due to the wall loss being concentrated next to the welding, Beruseal designed and manufactured a strongback restraint system that would be able to withstand total circumferential failure of the welding. The strongback was a multi part system that would restrain the elbow together with the complete assembled flange.
