CASE STUDY NUMBER:	Case Study 20
DESCRIPTION:	2" VALVE ENCLSOURE
CLIENT:

SERVICE:	
Line size	2"
Design Pressure	22,5
Operating Presure	21
Design Temperature	239
Operating Temperature	200
Material	SA-333 Gr6
Line Class	300

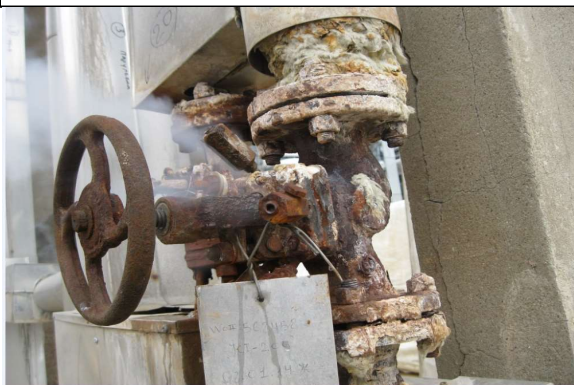
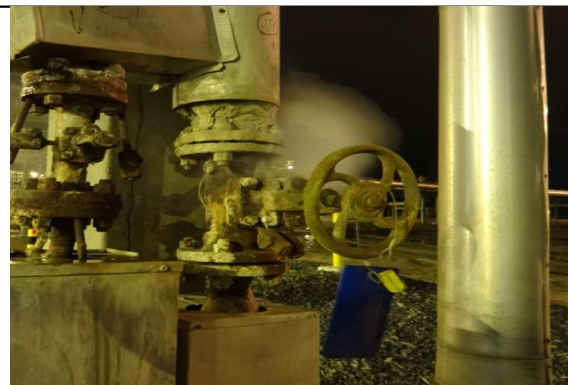
ANOMALY DESCRIPTION:
Steam leak from the glands and bonnet of a very old valve.

ROOT CAUSES
<p>A worn out bonnet gasket caused steam to leak out of the valve.</p> <p>The valve was previously repaired by pinning a wire between the bonnets and injecting polymer compound through the bonnet.</p> <p>Due to old age of the valve, the steam leak was discovered despite the previous repair that was done on the valve.</p>

INTEGRITY CONCERNS (INCLUDING PICTURES)
<p>The valve bonnet forms part of the piping pressure system and failure of the bonnet would result in catastrophic explosion of the valve and uncontrolled excessive service leak.</p>
