CASE STUDY NUMBER:	Case Study 19
DESCRIPTION:	2" VALVE FLANGE STRONGBACK
CLIENT:	TENGIZCHEVROIL

SERVICE:	
Line size	2"
Design Pressure	75
Operating Pressure	62
Design Temperature	156
Operating Temperature	156
Material	ASTM A479 Tp316
Line Class	600

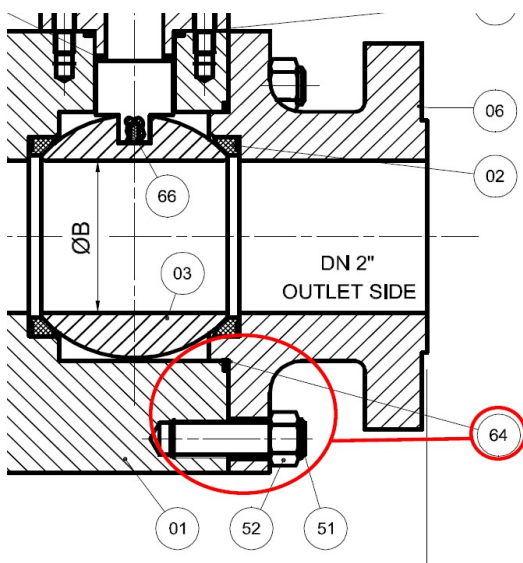
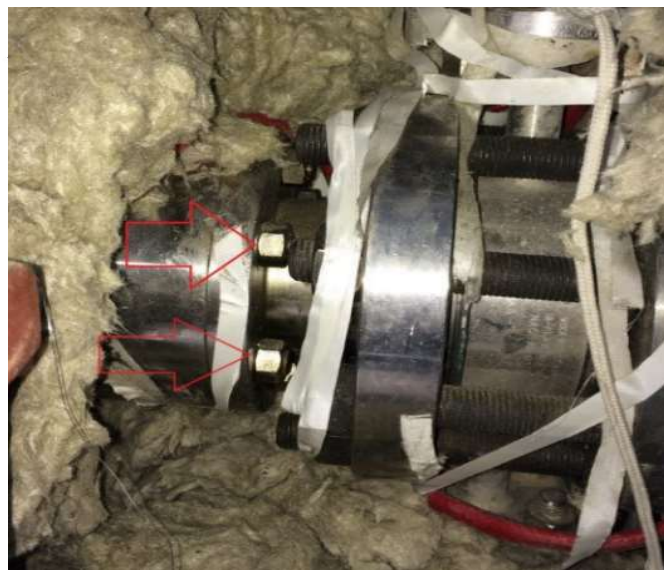
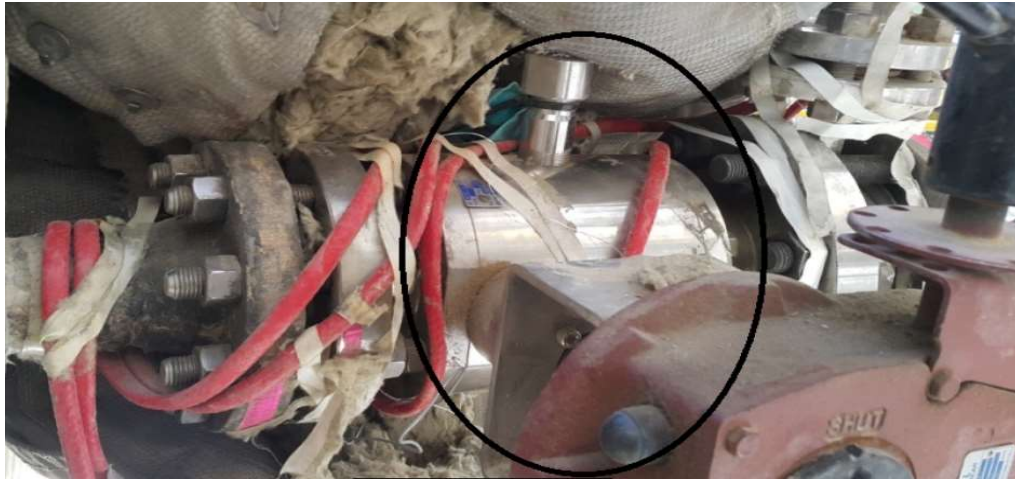
a H₂S leak was found on the body flange of a 2" Double block and bleed valve, H₂S was bypassing the gasket and leaking through the bolt holes.

the root cause of the leak is due to a deteriorated spiral wound gasket and body seal resulting in H₂S passing through into the bolt pockets of the valve body.

Further deterioration and complete failure of the 316 stainless spiral wound gasket leading to high amounts of H₂S leaking.

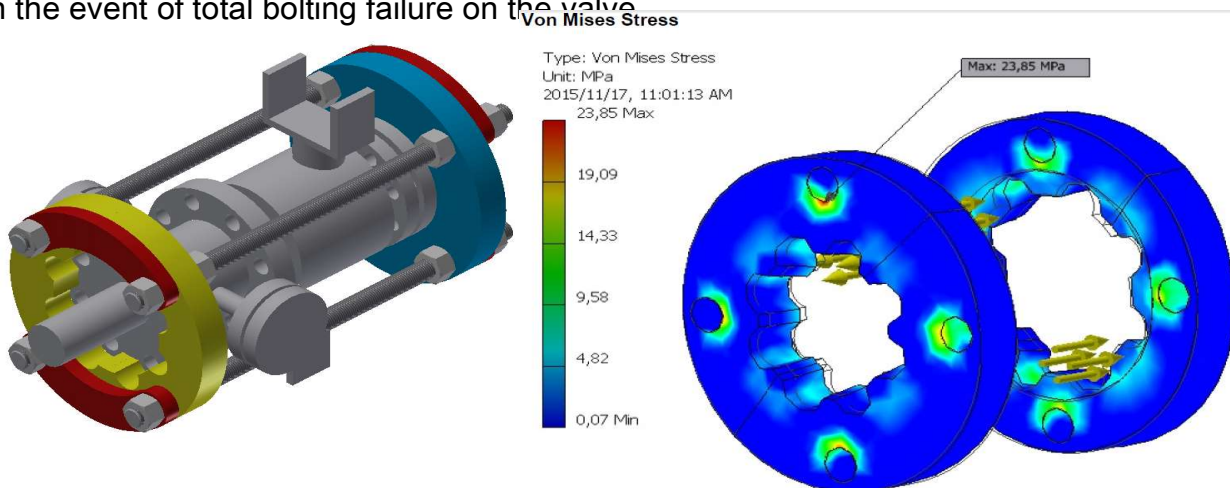
FEA analysis was performed on the strongback to analyse the stresses in the strongback in the event of total bolting failure on the valve

Beruseal designed and manufactured a stainless steel strongbacking system to contain the system should there be failure on bolting when drilling into each bolt pocket and injecting a PTFE sealant.

Injecting PTFE sealant puts additional strain on bolting where the condition and integrity of is unknown.
