**CASE STUDY NUMBER 7**  
**THROUGH WALL LEAK ON 36" SULPHUR DEGASSING UNIT**

CLIENT:	KAZAKHSTAN
DATE:	21 OCTOBER 2014
DESCRIPTION:	THROUGH WALL LEAK ON 36" SULPHUR DEGASSING UNIT
Service:	TECHNICAL AIR H2S
Line Diameter:	36" to 6"
Design Pressure:	14.5 BAR
Operating Pressure:	1 BAR
Design Temperature:	100°C
Operating Temperature:	90°C
Material:	A671 - CC60
Line Class:

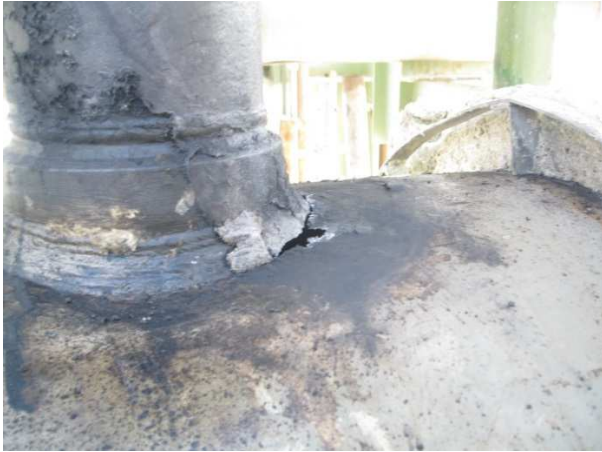
Picture 1

Visual inspection found through wall damage on the section of the line, Process Air line from pumps GB-401(refer to photo 1 & 2). Damage is located near tie-in 6" nozzle attachment weld of exhaust gases line from Sulfur Degassing Unit. UT scanning was performed to determine the condition of the area of damage and 6" nozzle. In accordance with inspection results, wall residual thickness in the area of damage is ≈4.7mm, in the adjacent areas T-min is 5.0mm, nominal thickness is 7.9 mm. Wall residual thickness of 6" nozzle is 5.8mm, nominal thickness is 7.11 mm.

The probable cause of this damage appearance is occurrence of wet acid corrosion mechanism due to missing of heat tracing on 6" nozzle tie-in of exhaust gases line from Sulfur Degassing Unit.

The length of through wall damage is ≈200mm and consists approximately 1/3 of nozzle attachment weld length, and may result in catastrophic failure of the nozzle.
