CASE STUDY NUMBER:	Case Study 23
DESCRIPTION:	3" DOUBLE VALVE ENCLOSURE
CLIENT:	TENGIZCHEVROIL

SERVICE:	
Line size	3"
Design Pressure	4,9
Operating Pressure	1
Design Temperature	50
Operating Temperature	10
Material	SA-333 Gr6
Line Class	150

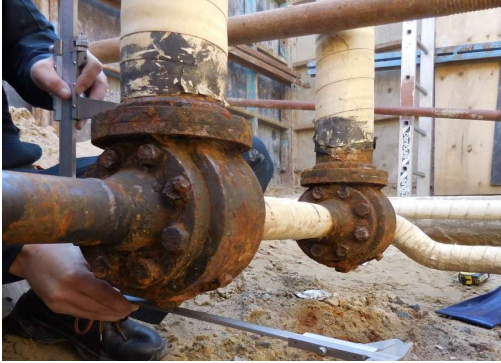
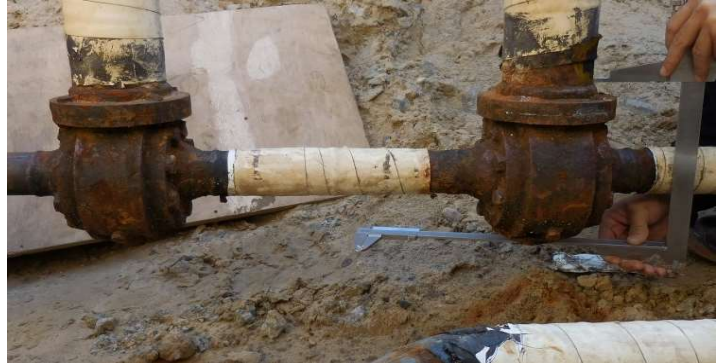
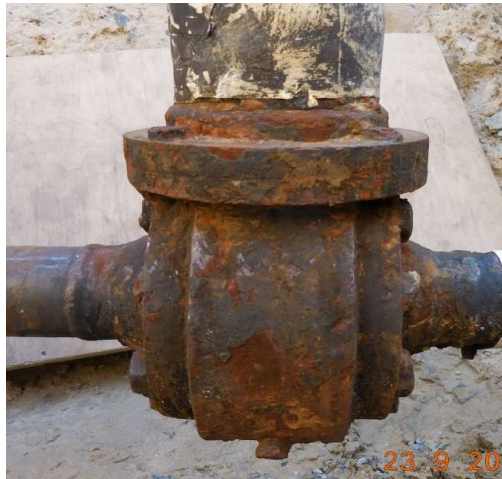
Underground piping was inspected and it was found that two valves in close proximity to each other had extensive corrosion on the body and bolting. The header piping is 2" and branches out the valve to 3". The remaining wall thicknesses of piping between the valves were also below thickness specification.

Piping being underground and having damaged and missing paint coatings

The Remaining thicknesses of underground sections where below the minimum allowable value which posed the risks that leaks may occur in the near future, With Possible environmental contamination due to loss of containment.
