CASE STUDY NUMBER:	Case Study 14
DESCRIPTION:	4" STRAIGHT LINE FLANGE CLAMP
CLIENT:	ESSO EXPLORATION ANGOLA

SERVICE:	
Line size	4"
Design Pressure	21
Operating Pressure	16
Design Temperature	110
Operating Temperature	110
Material	CAST CARBON STEEL, ASTM A216 GR WCB
Line Class	300

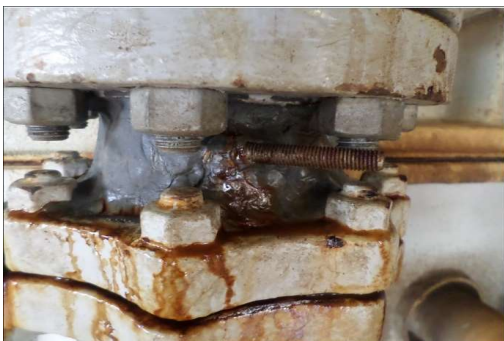
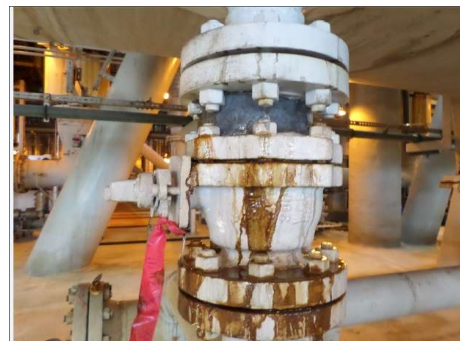
Numerous 4" ball drain valves sustained leaks on the neck of the valve body.

The current cause of the leak is not known.
 NDT inspection was performed and found that there was no internal corrosion.
 This leads us to believe that holes in the valve body were due to manufacturing defects.

Further deterioration of the defect could result in possible shutdown of equipment
 Due to the unknown cause of the defect, integrity of the piping is a concern.
 Loss of containment of hydrocarbon content poses a possible safety and environmental risk.
