CASE STUDY NUMBER 1

Mixed Sour Gas Manifold-Weld-O-Let cracks

CLIENT:	KAZAKHSTAN
DATE:	23 JANUARY 2014
DESCRIPTION:	Mixed Sour Gas Manifold-Weld-O-Let cracks
Service:	Sour Gas
Line Diameter:	20 to 2"
Design Pressure:	85 BAR
Operating Pressure:	66.7 BAR
Design Temperature:	190°C
Operating Temperature:	95°C
Material:	SA-358
Line Class:	900P21

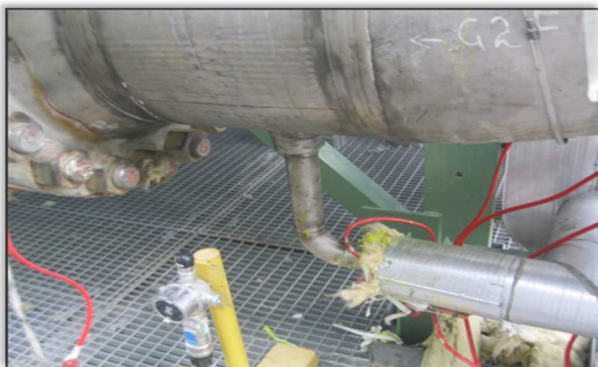
Picture 1

Axial orientated cracks were found in one butt weld and one fillet weld on a 2" pipe with RT on the U300 Mixing Manifold. (See attached photos 1 & 2 below)

Probable cause of the defects is availability of wet chlorides causing stainless steel chloride cracking

There was a high risk for the further growing of the known defects and it is not improbable that further defects may develop.

An analysis of a clamp for a sour gas line was made for the cracked weld-o-let. The design was to firstly seal the whole area to prevent leakage without putting any additional stress into the already cracked weld, and secondly, support the drain should the weld crack through completely. Beruseal designing dept designed a strong-back clamp and used FEA (Finite element analyses) technology to determine stress levels that would be imposed on the clamp in the event of catastrophic failure of the weld. The design was made according to ASME PCC2 and underwent stringent analysis by Client engineering house Department and found to be acceptable. (See attached pictures 3 & 4 below).
