CASE STUDY NUMBER 2

Partially submerged 26" riser repair

CLIENT:	Nigerian Platform
DATE:	4 May 2010
DESCRIPTION:	Damage to Riser
Service:	Crude
Line Diameter:	26"
Design Pressure:	740PSI
Operating Temperature:	50°C

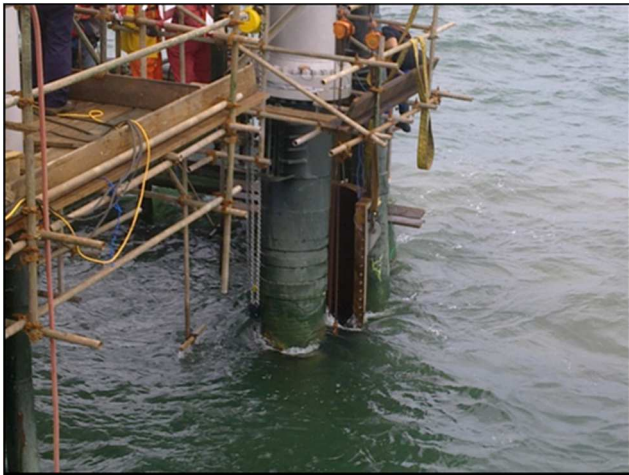
Picture 1

The Riser had a slight leak and was deformed. (See attached photos 1 & 2 below) Numerous attempts were made by different Vendors to repair damage to a platform riser by means of composite repair systems. The repairs however were unsuccessful.

Root causes:
Riser damage.
