CASE STUDY NUMBER:	Case Study 35
DESCRIPTION:	14" Crude line support wraps
CLIENT:	SAPREF

SERVICE:	Crude oil
Line size	14"
Design Pressure	31,5 Bar
Operating Pressure	2,59 Bar
Design Temperature	60Deg C
Operating Temperature	26 Deg C
Material	Sa 106 GrB
Line Class

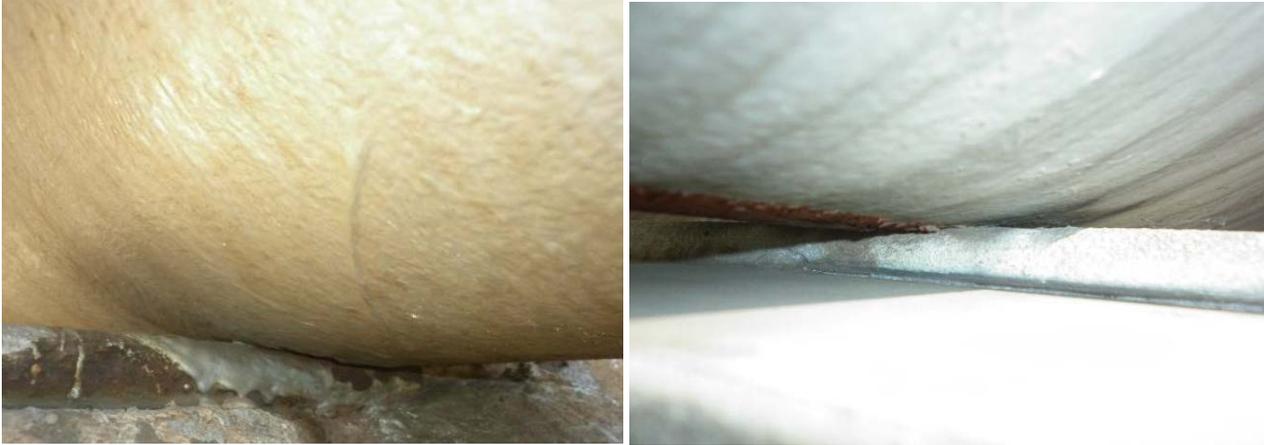
The 14" Crude line that supplies to the refinery was inspected and noted that severe external pitting corrosion was found on the contact areas where the pipe meets the concrete sleepers. 178 support sections were identified with 27 that had major wall thinning. Major findings had wall losses of approximately 70percent.

2 7mm wall left from an original 9 52mm

improper design of sleeper support without any sacrificial wear material, for example a metal wear pad. The pipe sits directly on a 20mm diameter round bar and with vibration and movement of the pipeline over the years it has started eating away at the localised spots where the pipe meets the roundbar.

Further deterioration could lead to possible leaks on the pipeline. The pipeline is the crude oil supply to the refinery which could result in major downtime, fire and environmental hazards. Major findings it is reported that the line is operating at below the design minimum thickness due to design pressure.

Beruseal engineered a diamond wrap composite repair according to ASME PCC2 to restore the pipeline wall thickness back to its original specification and enable it to operate at full design conditions. Out of the 178 supports Beruseal wrapped a total of 27 sections that were below the pipeline's T-min.
