## CASE STUDY NUMBER 3

Failed gasket on Heat exchanger

CLIENT:	Oil Field Kazakhstan
DATE:	20 January 2011
DESCRIPTION:	Leaking Heat Exchanger
Service:	Sour Service
Line Diameter:	Heat exchanger
Design Pressure:	87 BAR
Operating Pressure:	75 BAR
Design Temperature:	350°C
Operating Temperature:	420°C
Material:	SA-358
Line Class:

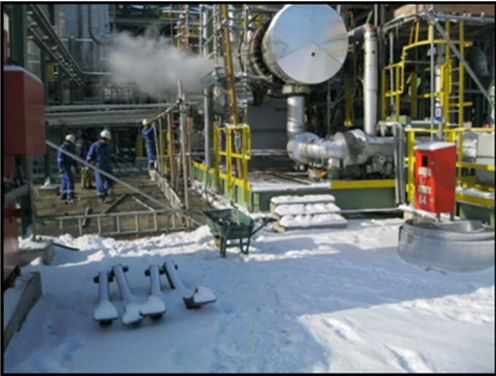
Picture 1

H2S gas leaking from Heat exchanger shell flange, Bolts were unsuccessfully re-tensioned in attempt to eliminate leakage

Probable cause of the defects severe Thermal cycling

An analysis of a clamp for a sour gas line was made for the Heat Exchanger. The clamp design was merely a contingency should the brass wire wrap method not have adequate support.
