CASE STUDY NUMBER:	Case Study 18
DESCRIPTION:	PRE-HEATER FLANGE CLAMP
CLIENT:	TENGIZCHEVROIL

SERVICE:	
Line size	3410 x 320mm
Design Pressure	4
Operating Pressure	0,48
Design Temperature	260
Operating Temperature	166
Material	ASTM A350 LF2 CL.1
Line Class	SPECIAL-TUBESHEET/CHANNEL

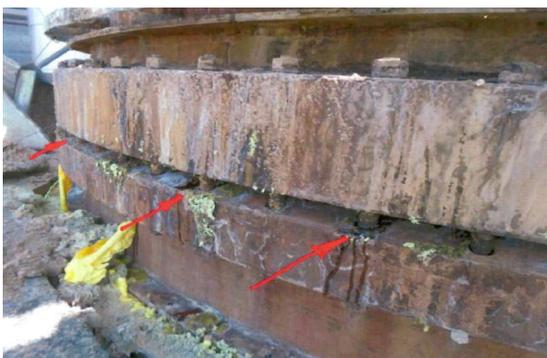
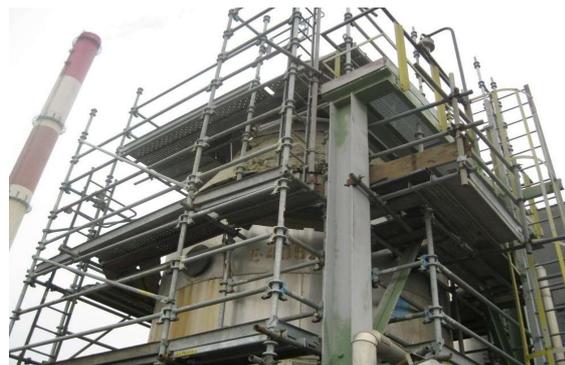
A small leak was detected on the body flange of vessel. The gasket and studs are over 20 years old. The existing studs was corroded and could not be re-tightened. The existing sheet gasket is completely confined and can withstand a higher compression gasket load.

A bolt changeout procedure was completed by the client yet the leak of H2S was still present

Deterioration of the Gasket and studs that have been in service for 20 years without replacement.

Further degradation of gasket and bolting leading to increased exposure of H2S into the environment. H2S exposure to human health is hazardous and large amounts of exposure could be fatal.

There was also a risk of Stress Corrosion Cracking due to bolting being exposed to sour service.
