CASE STUDY NUMBER:	Case Study 21
DESCRIPTION:	FLANGE SURFACE CLAMP
CLIENT:

SERVICE:	H2S
Line size	N/A
Design Pressure	4
Operating Pressure	1,45
Design Temperature	440
Operating Temperature	150
Material	A350 Gr LF2 / A182 Gr F12
Line Class	N/A

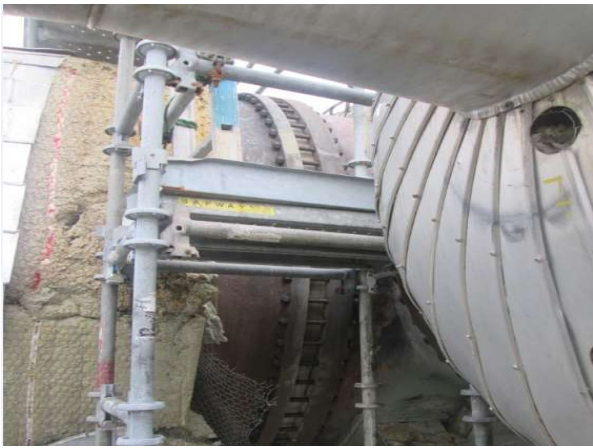
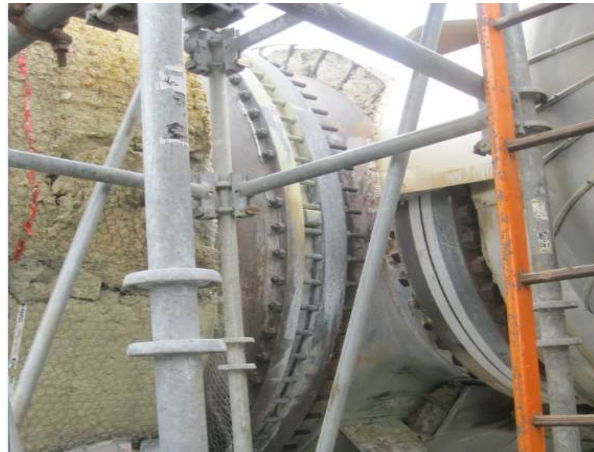
ANOMALY DESCRIPTION:
A leak has been detected on the body flange of a vessel during gas regeneration process. The Vessel flanges had a diameter of 2700mm

ROOT CAUSES
A worn out flange gasket caused gas leak through the vessel body flanges. Leak occurred when gas temperature increases in regeneration cycle.

INTEGRITY CONCERNS (INCLUDING PICTURES)
<p>During regeneration cycle, gas temperature increases as well as its pressure causing process service to leak through the worn out flange gasket.</p> <p>Since the process service is highly corrosive, its leakage would corrode the vessel flanges and bolting system.</p> <p>Corrosion of the vessel flanges and bolting system would result in weakening of the vessel's structural integrity followed by excessive leakage of a very flammable and toxic process service.</p>
