CASE STUDY NUMBER:	Case Study 26
DESCRIPTION:	3/4" Clamp Enclosure
CLIENT:	TENGIZCHEVROIL

SERVICE:	Steam
Line size	3/4"
Design Pressure	23Bar
Operating Pressure	20Bar
Design Temperature	240°C
Operating Temperature	210°C
Material	CS
Line Class	300#

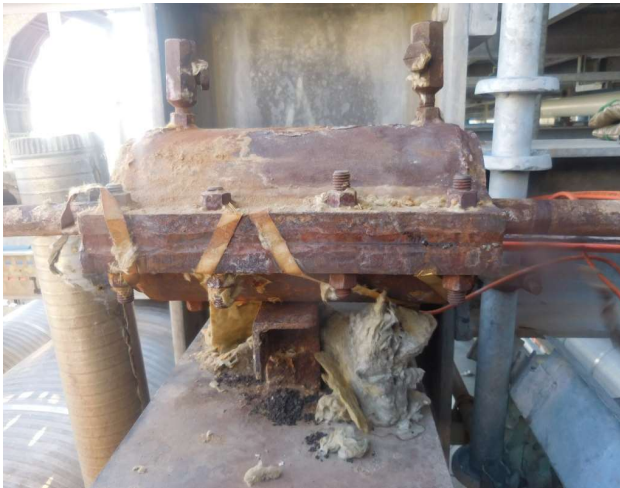
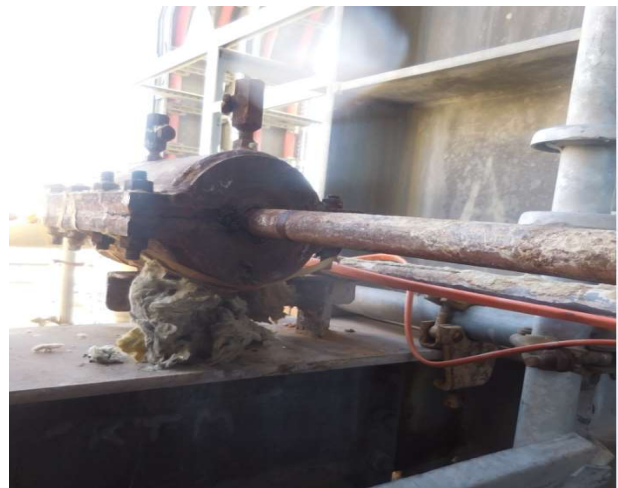
ANOMALY DESCRIPTION:
A leak was detected on an old clamp. And a shutdown for replacing the line and removing the clamp was not possible.
ROOT CAUSES
The existing clamp was too old to re-inject, so there was a need to cover the entire clamp in order to stop the leak. The leak was caused by the old age of existing clamp and/or sealing compound. The existing enclosure also posed a safety risk as the enclosure was kept on the line longer than the original design lifetime.

INTEGRITY CONCERNS (INCLUDING PICTURES)
The old clamp will not be able to keep the piping in position in the case of complete failure of the original defect. In case of complete failure, the pipe will slip off the clamp easily due to degradation of existing clamp and result in a plant upset.

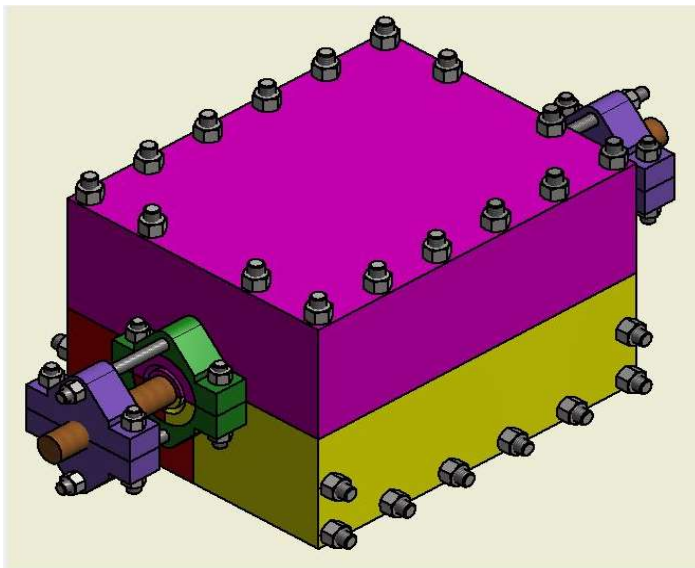
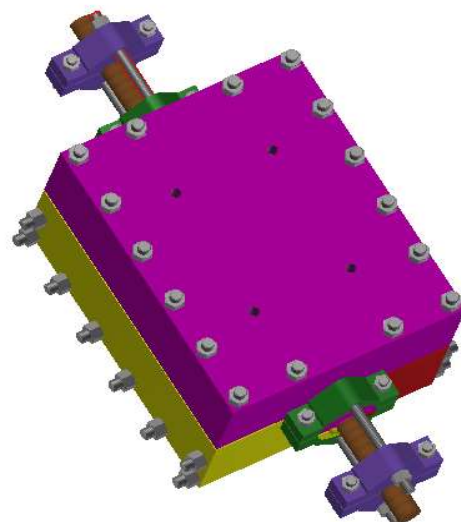
THE BERUSEAL SOLUTION (WITH PICTURES)

Due to the above structural concerns (and clamp leak), a clamp was designed according to ASME VIII Div 1 to cover the existing (old) clamp. An interlink strongback system was also incorporated into the design to prevent piping-separation in case of complete failure of the original defect. Therefore, the interlink strongback system helps to maintain the structural integrity of the piping. Due to space constraint it was decided to manufacture and design a three part enclosure CNC machined from 120mm plate. The three part enclosure would allow the bottom half to slide into position ontop of the existing structural beam that could not be removed.

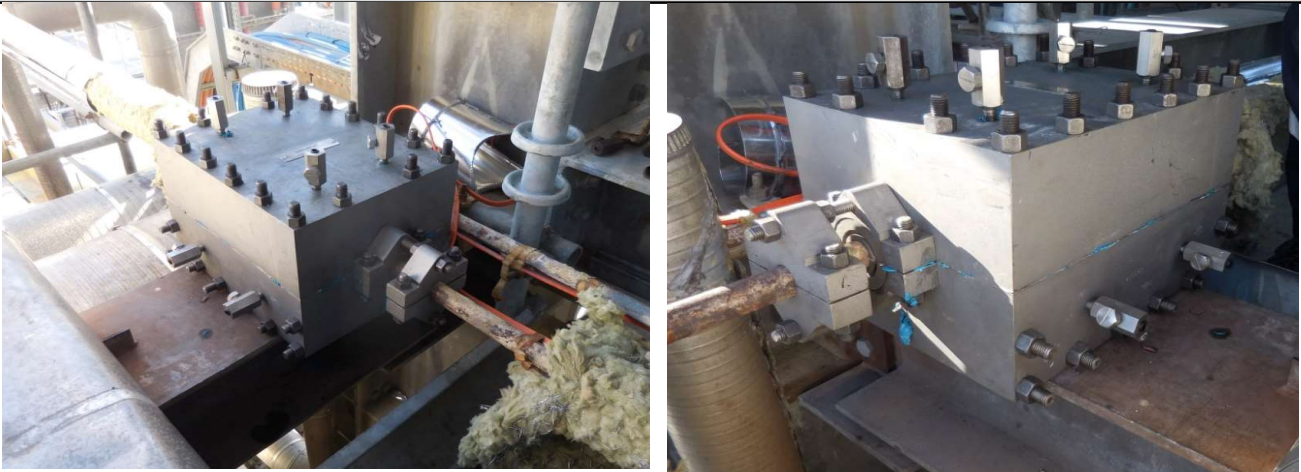
INSTALLATION PICTURES

A successful seal was obtained by injecting a polymer compound into the clamp cavity. After injecting compound, no leaks were observed therefore a successful seal was achieved.
