CASE STUDY NUMBER:	Case Study 16
DESCRIPTION:	3/4" T-piece Enclosure and restraint
CLIENT:	TENGIZCHEVROIL

SERVICE:	Condensate steam
Line size	3/4"
Design Pressure	10Bar
Operating Pressure	4,5Bar
Design Temperature	215 DegC
Operating Temperature	150 DegC
Material	SA333 Gr6
Line Class	150#

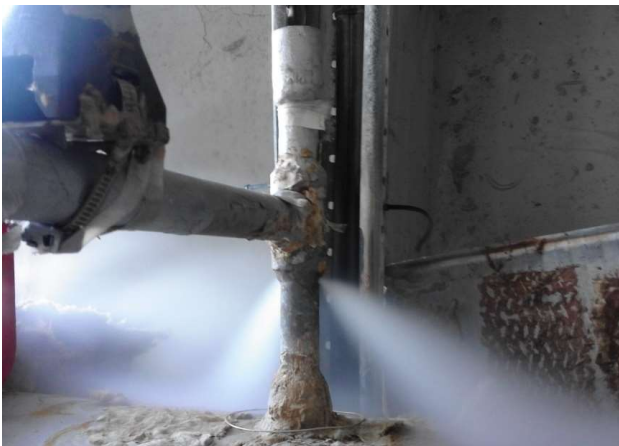
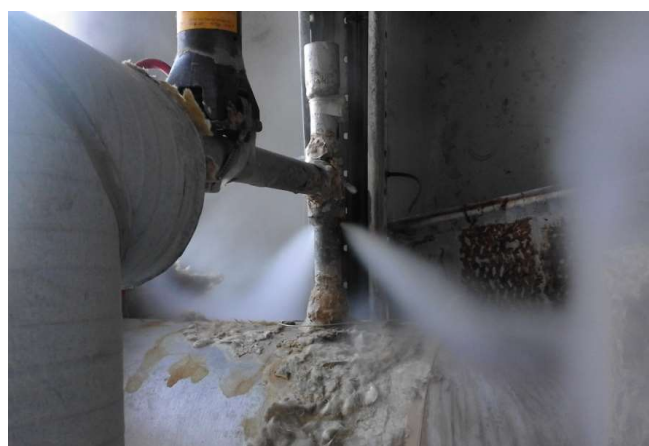
INTEGRITY CONCERNS (INCLUDING PICTURES)

Through hole found in T-piece welding resulting in steam leak.

internal corrosion and possible welding defect on the T-piece weld

Further deterioration of weld could result in separation of the T-piece from the piping, this could have resulted in possible shutdown of equipment and production loss.

Due to the possibility of a complete weld failure a strongback system had to be put in place to keep the system intact in the event of failure of the weld. Space below the T-piece enclosure was very limited and Beruseal devised a plan to design a restraint that went around the larger diameter pipe and ties in together with the enclosure.

a polymer compound was injected into a sealing groove to avoid sealant entering the line through the defect, and a safe and successful repair was implemented that allowed the client to operate at full capacity until the next planned shutdown.
