CASE STUDY NUMBER:	Case Study 17
DESCRIPTION:	3/4" T-PIECE CLAMP WITH STRONGBACK
CLIENT:

SERVICE:	
Line size	3/4"
Design Pressure	10
Operating Pressure	4,5
Design Temperature	215
Operating Temperature	150
Material	SA-333 Gr6
Line Class	150

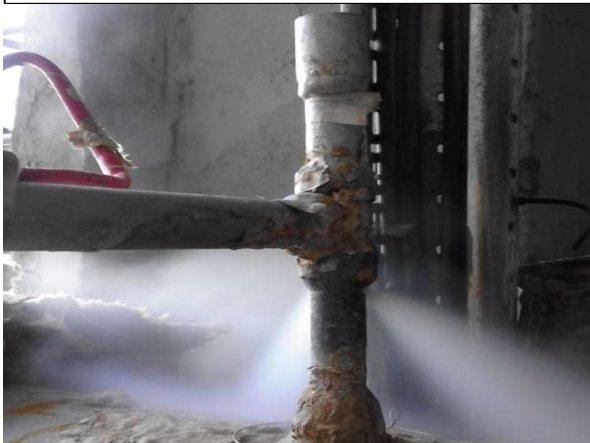
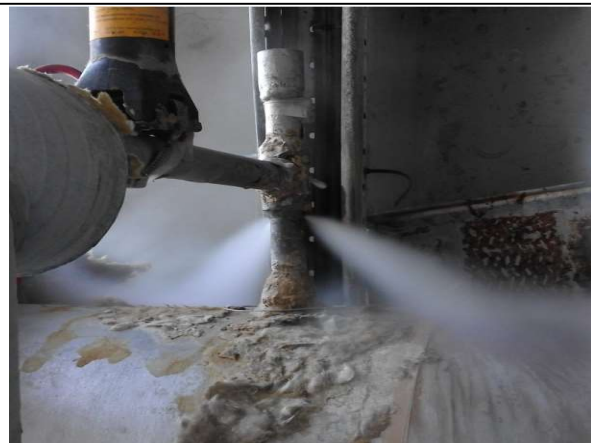
ANOMALY DESCRIPTION:
A steam leak was discovered from welding on the T-Piece

ROOT CAUSES
The leak was caused by a crack on the welding. The pipe was also reported to have an extremely low remaining wall thickness (throughwall).

INTEGRITY CONCERNS (INCLUDING PICTURES)
The pipe was in a critical condition due to the lowest remaining wall thickness (throughwall). Due to the remaining wall thickness (throughwall), the pipe could suddenly rupture/fail any time therefore, the integrity of the piping was a major concern.

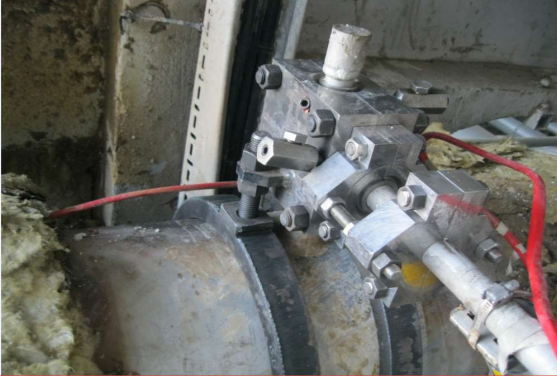
THE BERUSEAL SOLUTION (WITH PICTURES)

A T-piece clamp was designed according to ASME VIII Div 1 to cover the entire T-piece pipe section including the cracked welding.

A strongback system was also designed to keep the clamp in place should there be a complete failure of the cracked weld.

The strongback system also adds structural integrity to the piping since the remaining wall thickness is extremely thin (below minimum acceptable thickness).

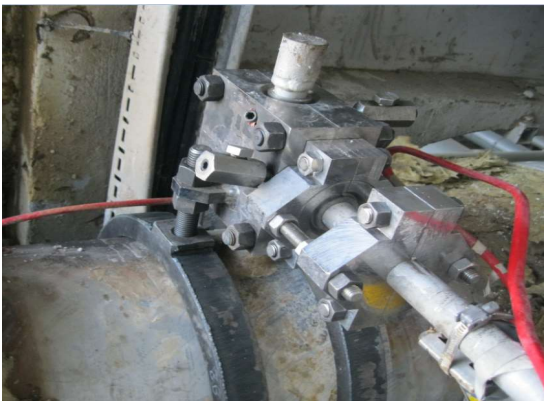
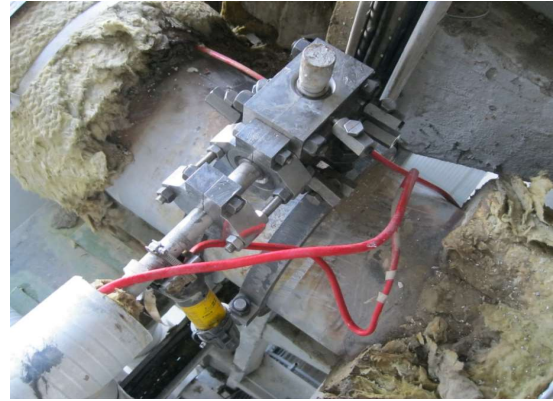
INSTALLATION PICTURES

A successful seal was obtained by injecting a polymer compound into a sealing groove that runs throughout the seam and bores of the enclosure.
