# CASE STUDY 118

## 26" Wellhead

| Description | 20" x 2" Top Hat Enclosure |

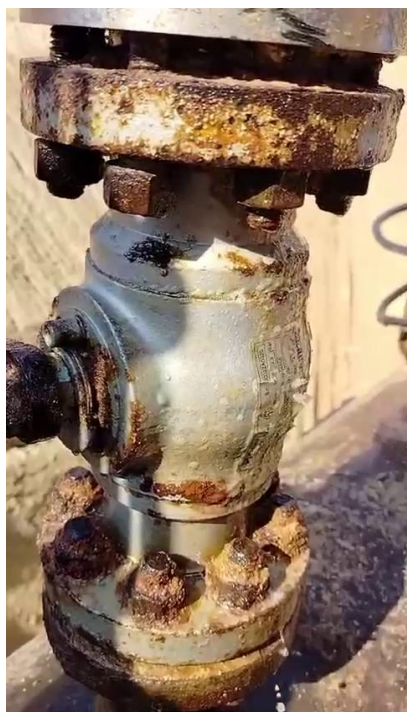
Before Photo

The anomaly involved a pressurized gas leak identified on a 2" instrument isolation valve body within a production pipeline system. Specifically, the leak was located at the flanged end connection stub where it joins the body of the valve. Visual inspections and testing confirmed the valve was weeping from the bonnet under an operating pressure of 30 bar, creating a hazardous atmosphere and necessitating immediate containment to prevent a full loss of integrity.

The risk of a catastrophic release of flammable dry gas into the atmosphere. The "weeping" bonnet posed a fire and explosion risk, especially given the presence of detectable Lower Explosive Limit percentages. Furthermore, the continued thinning of the valve body suggested that the leak would likely escalate if left untreated.

To contain the leak, a custom-engineered "Top Hat" enclosure assembly (20" x 2") was designed and manufactured in accordance with ASME PCC-2 and BPVC Section VIII Division 1 standards. The solution utilized a specialized enclosure with a typical caulking lip design and high-pressure sealant injection ports to create a secondary pressure boundary around the failing valve. Following the "Live Repair" installation, the assembly was subjected to rigorous non-destructive examination, including 100% Magnetic Particle Inspection (MPI) on all welds, to ensure the long-term containment of the 30 bar process service.
